SPECIAL FLOOD CONTROL REPORT

Los Angeles, San Gabriel, Santa Ana Rivers, California

FLOOD CONTROL  
FIELD COORDINATING COMMITTEES 18-20  
March 29, 1938

PHOTOGRAPHS

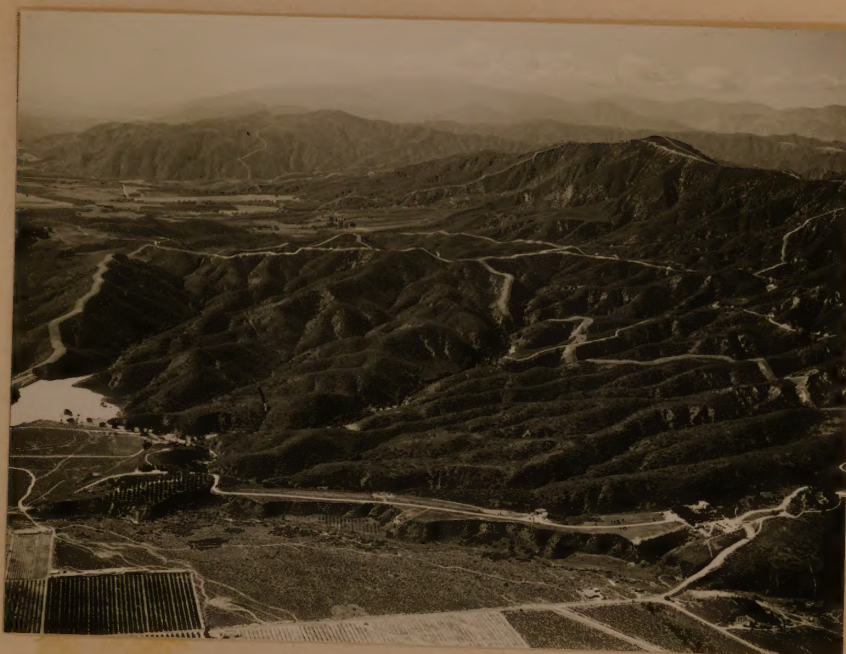
PLATE 1

- A. Dense shrub cover afforded maximum protection to watershed slopes, although intensity and duration of the 1938 storm caused heavy runoff that scoured many years' accumulation of debris from the canyon bottoms. Santa Ana watershed, east of San Bernardino.

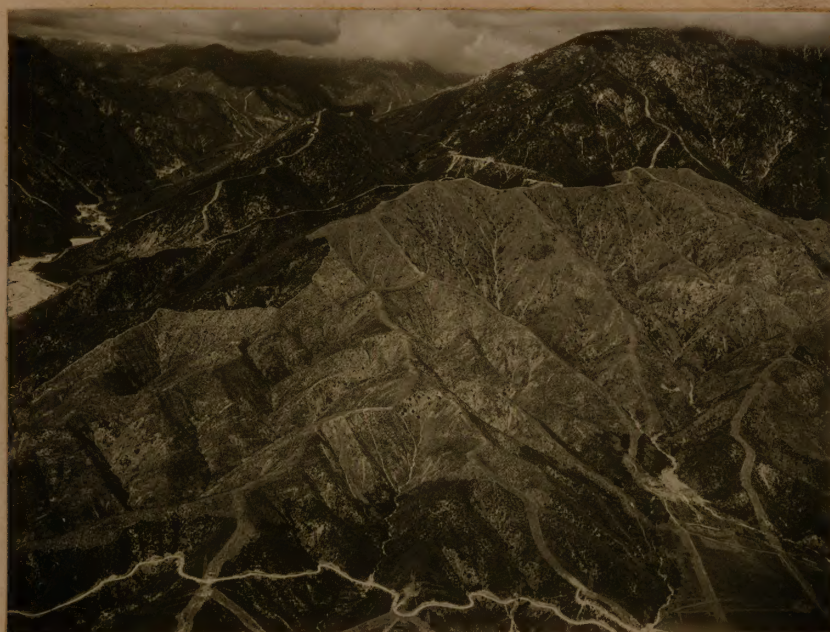
S.C.S. HMG-2

- B. Barred soils, severe erosion, and rapid runoff cause floods below fire-damaged watersheds. This area has yielded debris during each storm since its denudation in 1935; it was stable before the fire. Frankish Canyon, Santa Ana watershed, San Bernardino N. F.

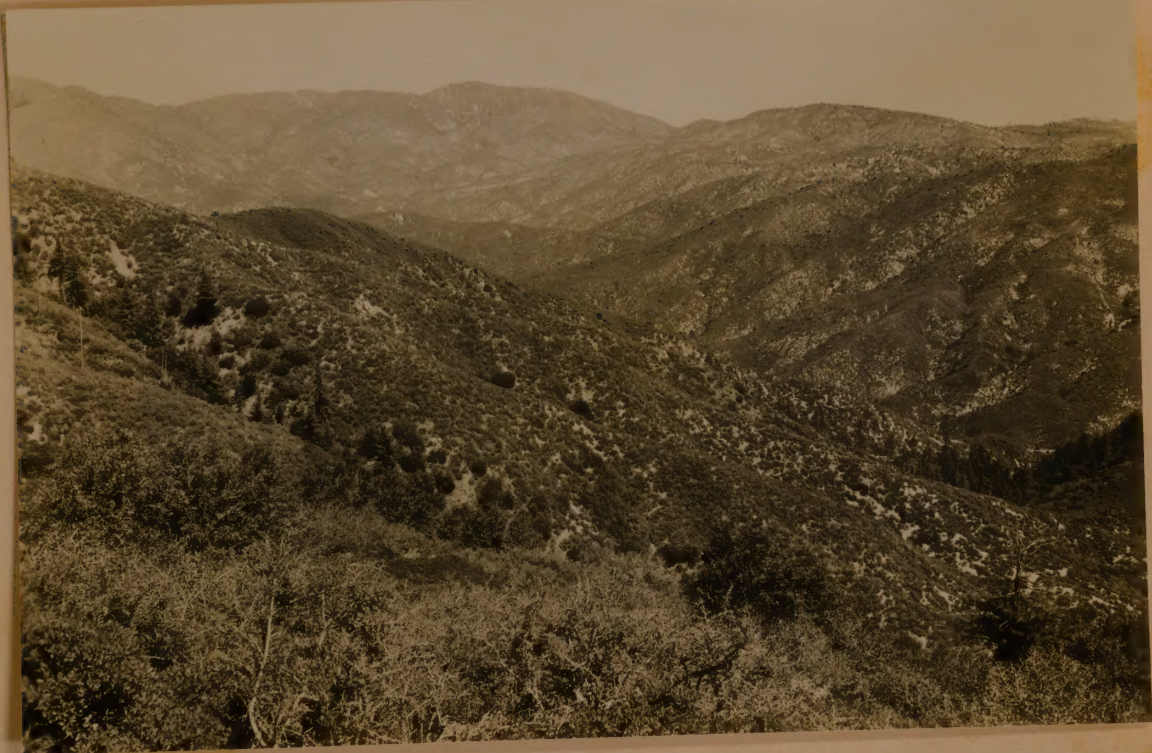
U.S.F.S. DMI-883

- A. Slow recovery of vegetation twenty years after fire, in Big Tujunga drainage, Los Angeles watershed. This condition aggravates flood and erosion problems.

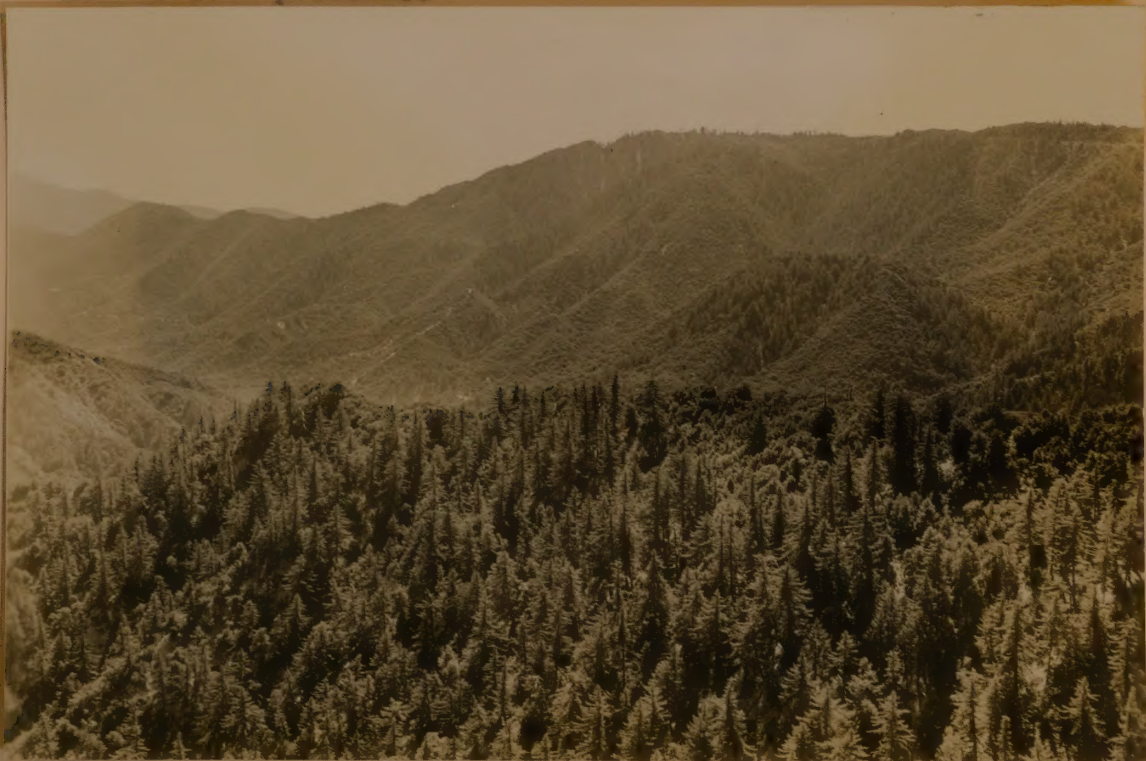
U.S.F.S. DMI-884

- B. Vegetation of well-forested watersheds gives maximum protection against erosion. West fork, San Gabriel drainage, Mt. Wilson on center skyline.

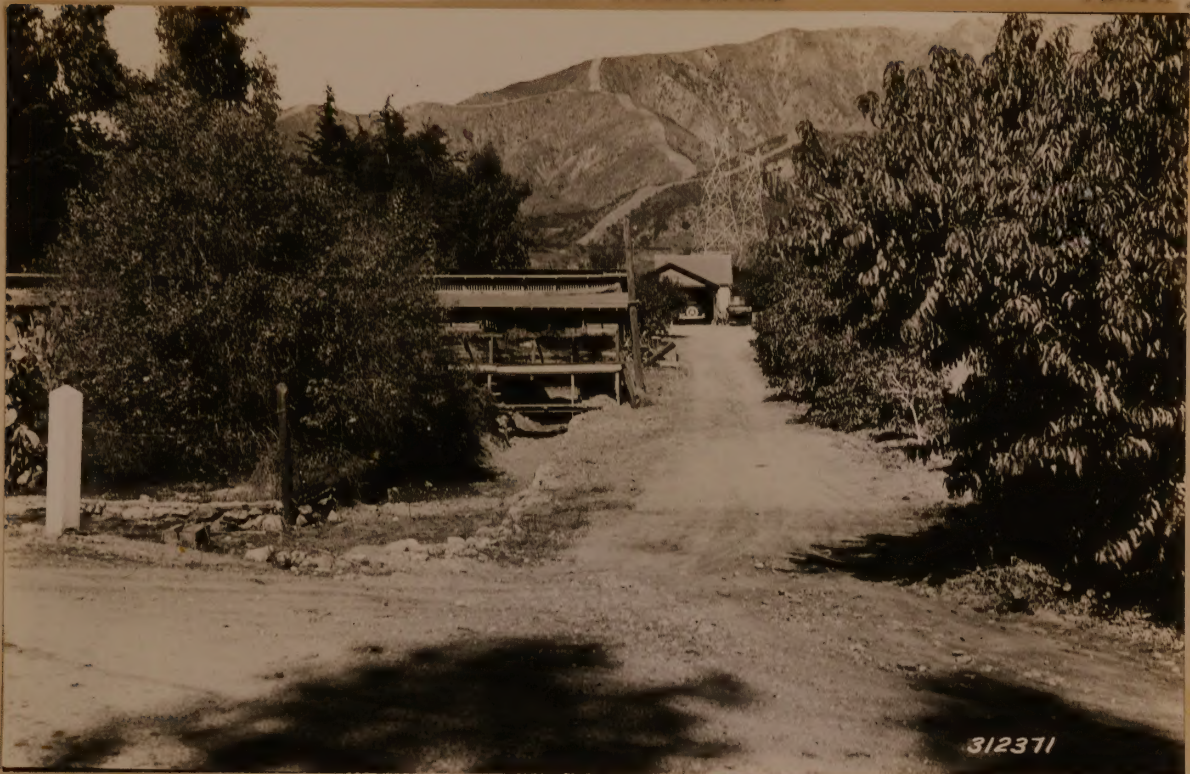
U.S.F.S. 312371

- A. Under normal conditions of watershed cover, these buildings in Frankish Wash were safe for many years. Even peak runoff of 1933-34 New Year's storm passed safely through drain under sheds.

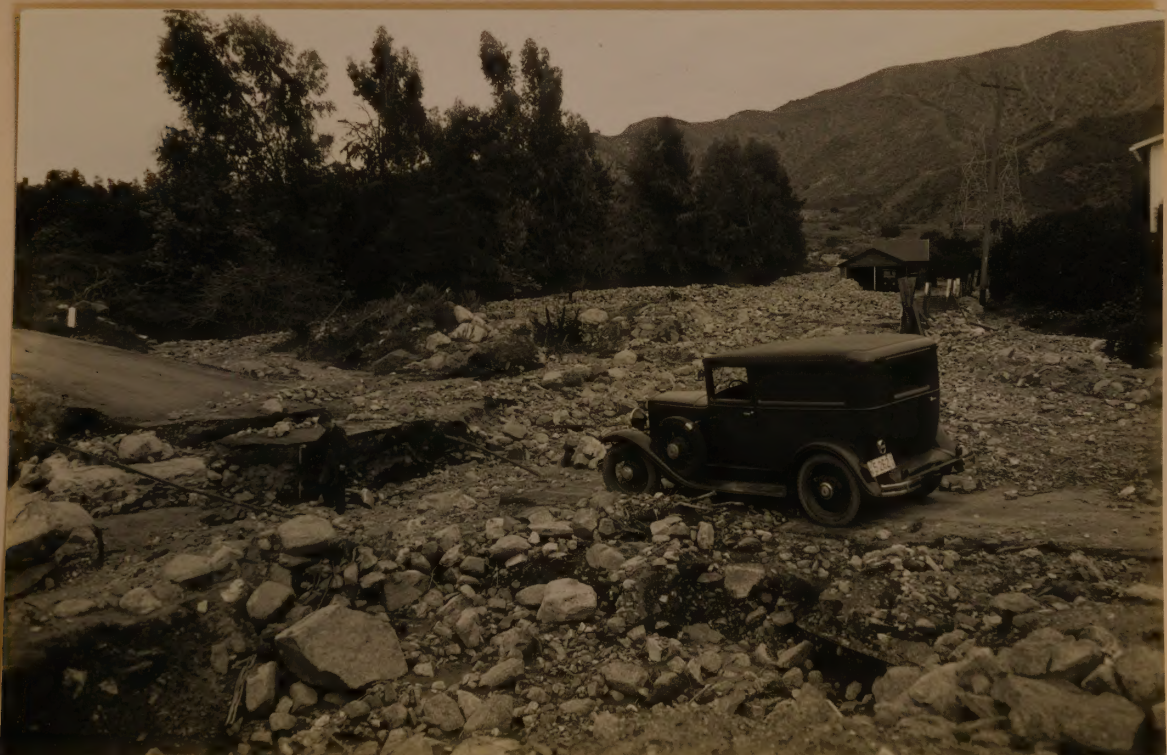
U.S.F.S. CHG-1426

- B. Delivery of debris started with first storm following denudation of the watershed by fire in 1935, and is still continuing. Buildings shown above were destroyed and \$50,000 of damage was done to homes, citrus groves, and streets the first winter alone. Frankish Canyon, Santa Ana watershed.

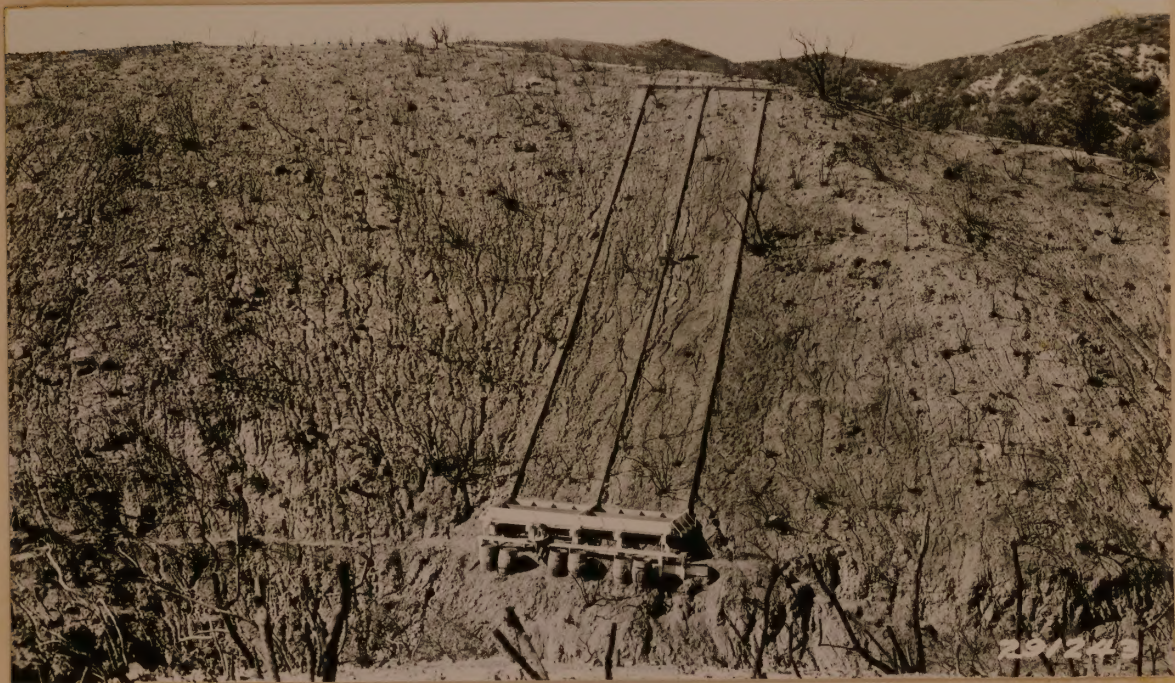
U.S.F.S. 291243

- A. Denuded by fire, these 1/50-acre plots in 3-inch storm of February, 1934, eroded at rate of 19,000 cu. yds. per square mile (direct conversion). Haines Experimental Area, Pickens burn, Los Angeles watershed.

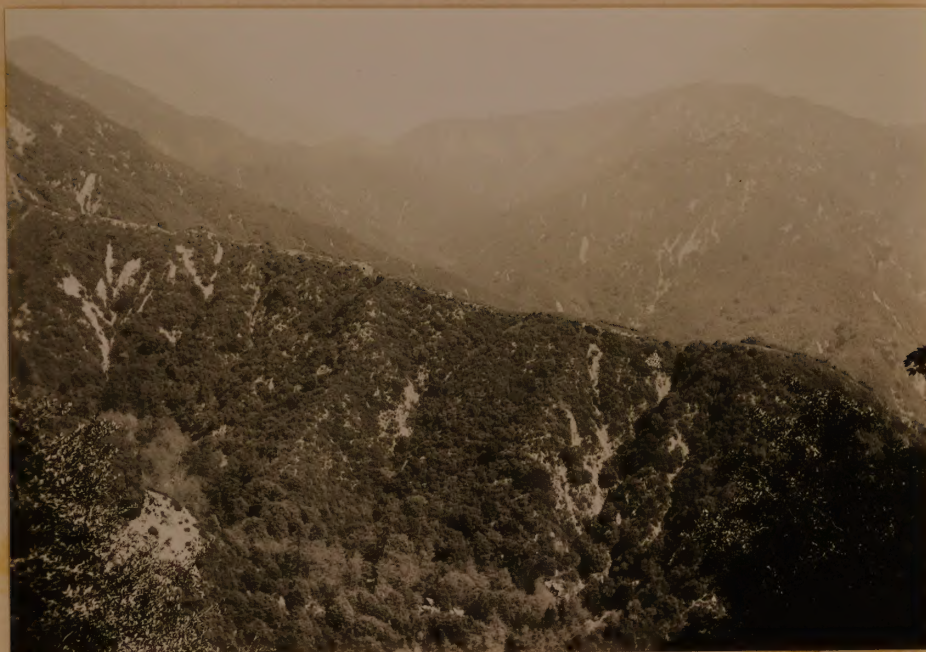
U.S.F.S. WTC-26A

- A. Slumping and land-slips occurred widespread along the mountain front above Altadena. Attributed primarily to excessive steepness of the slopes, it was greatly augmented by trails and firebreaks. Big Santa Anita Canyon, San Gabriel watershed.

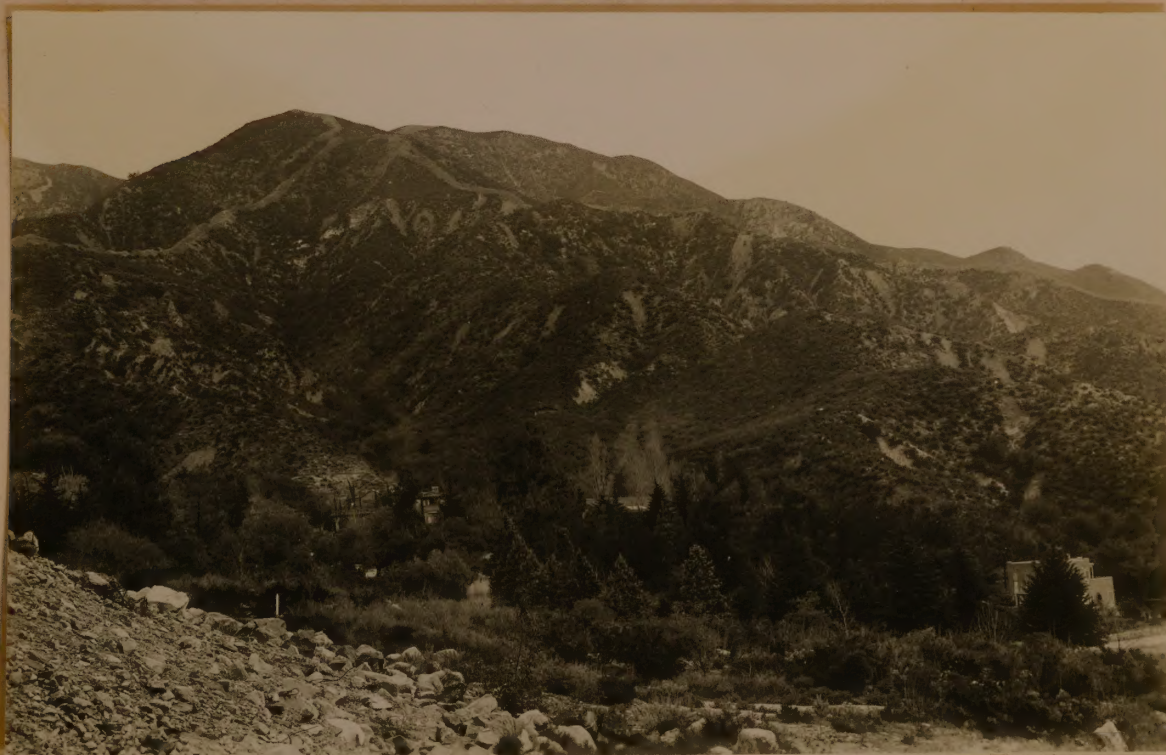
U.S.F.S. CHO-1443

- B. Slumps and slides were larger and more serious in fire-denuded areas of like topography. Pickens burn of 1933, Los Angeles watershed.

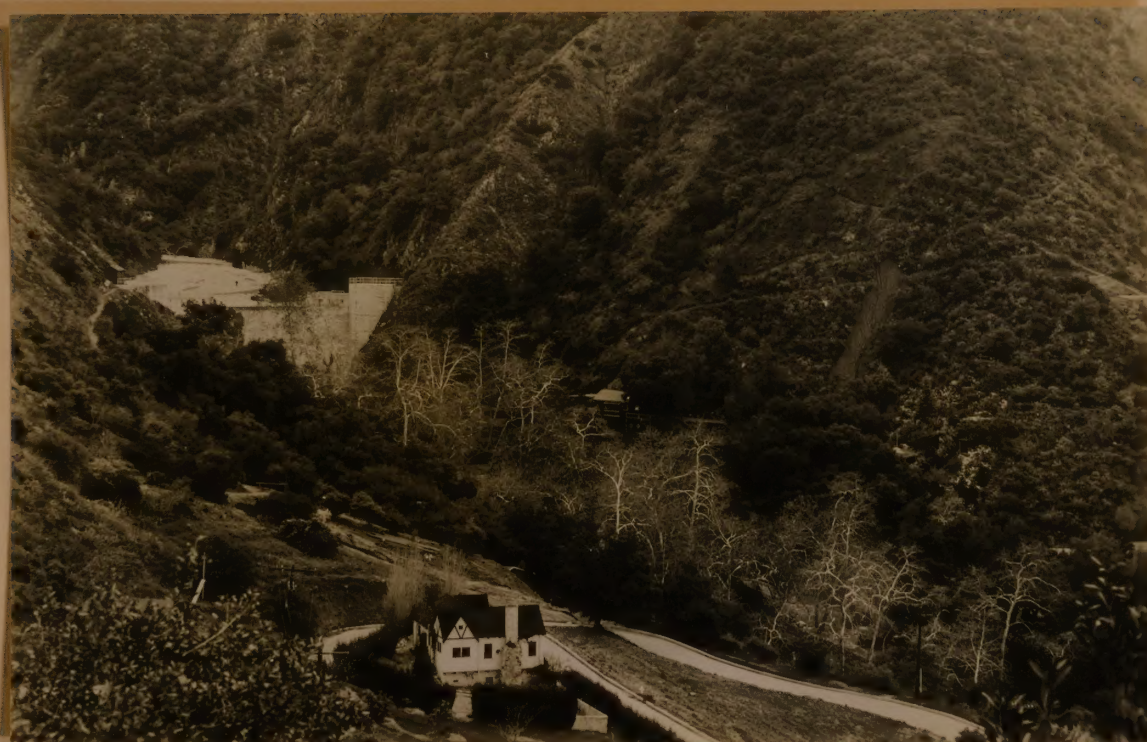
U.S.F.S. CHG-1401

Flood control dam built in 1928 estimated two-thirds filled with debris by 1938 flood. Storage capacity 76,500 cu. yds., drainage area 2.39 sq. mi. Watershed is exceedingly rugged, probably not burned since 1900. Sierra Madre Dam, San Gabriel watershed.

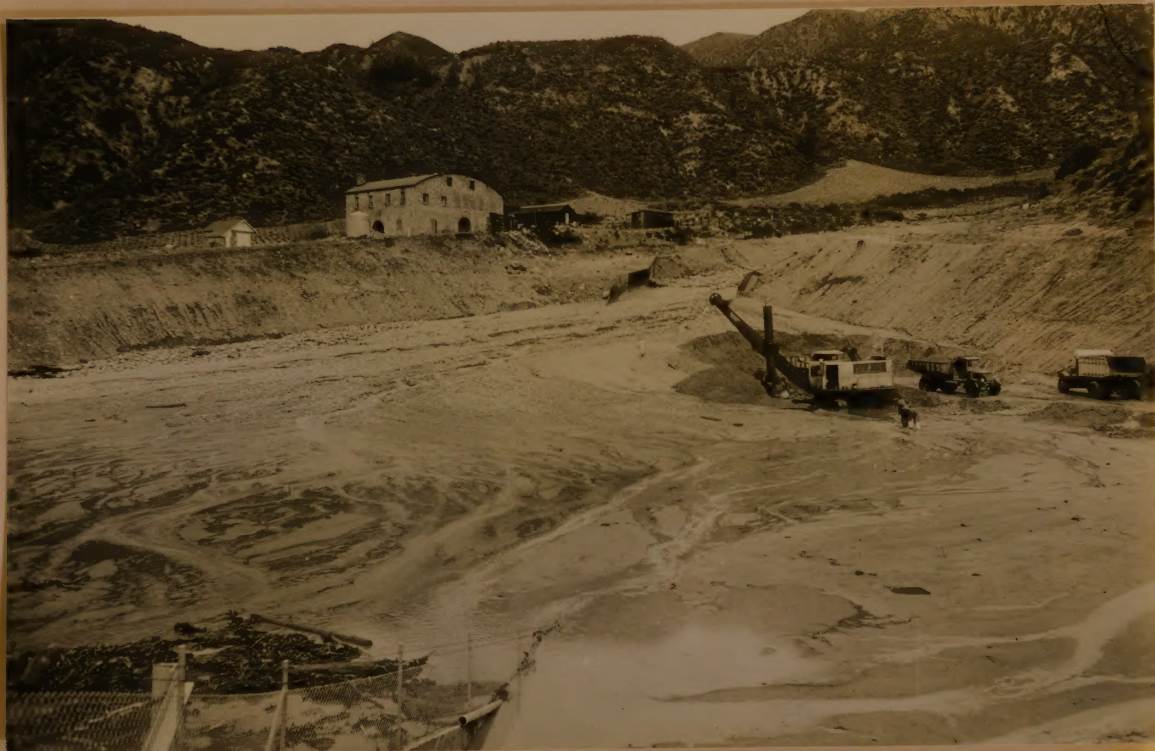
U.S.F.S. CHG-1442

- A. Debris basin below Pickens burn of 1933, typically filled to capacity March 2. Erosion rate 125,000 cu. yds. per sq. mile. (tentative) from exceedingly rugged 0.84 sq. mile canyon. Dunsuir Basin, Los Angeles watershed.

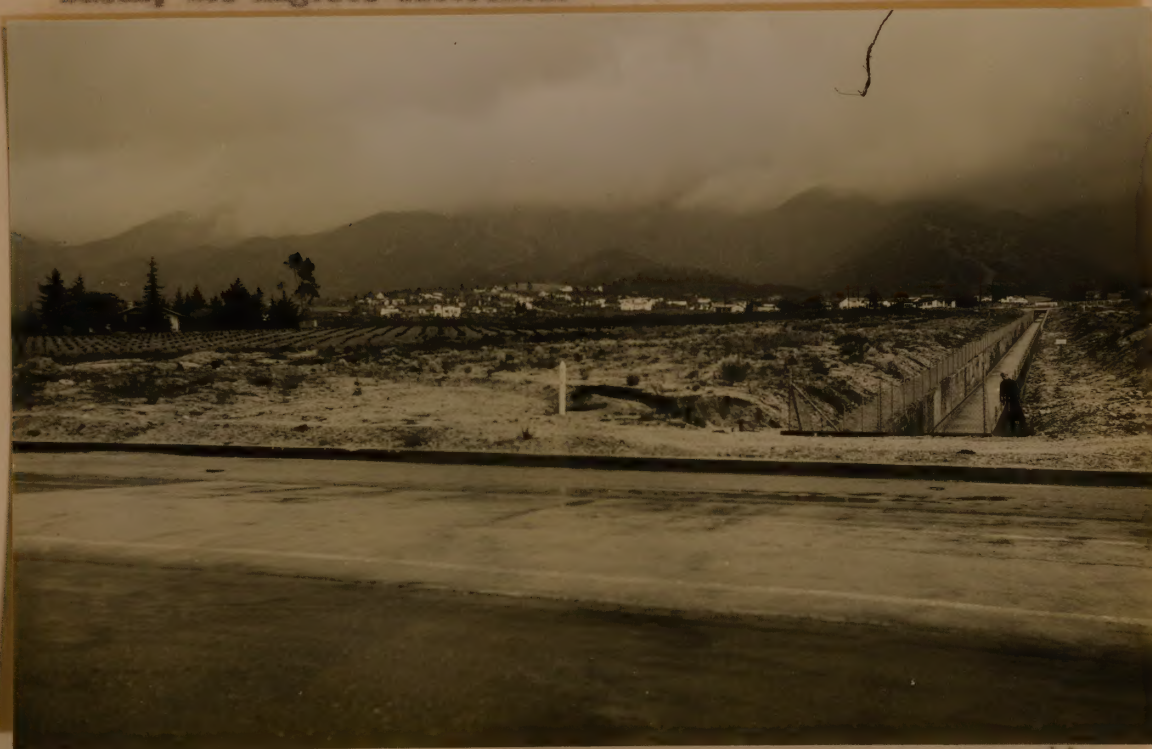
U.S.F.S. CHG-1440

- B. Costly storm drains led the desilted flood runoff harmlessly from each debris basin toward the sea, proving highly effective in preventing flood damage in this region.

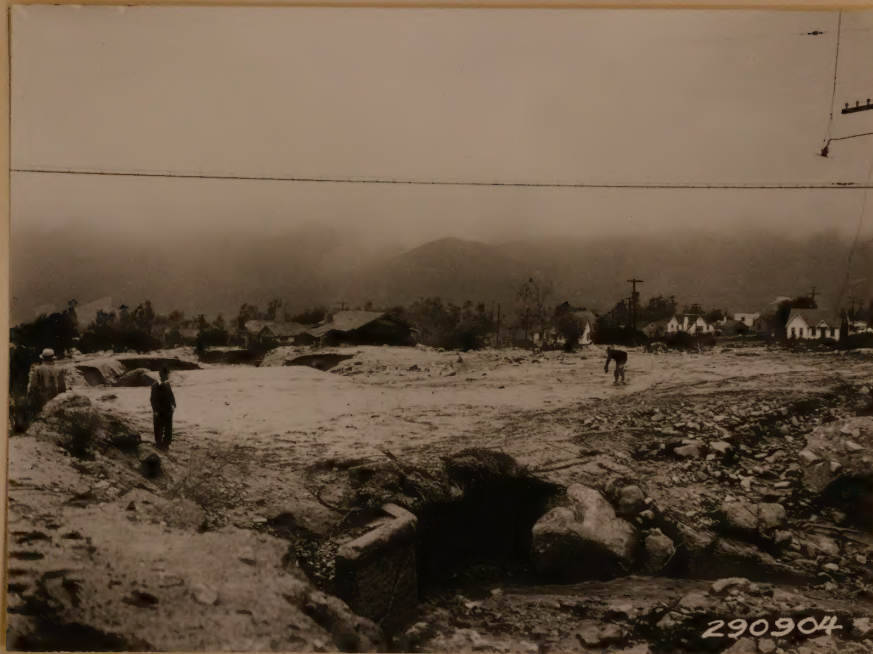
U.S.F.S. 290904

- A. Destruction wrought in New Years storm of January 1934 by debris flows from Pickens burn. All storm drains were inadequate for heavy runoff experienced. Note flood-punctured house. Pickens wash culvert under Foothill Blvd., La Crescenta.

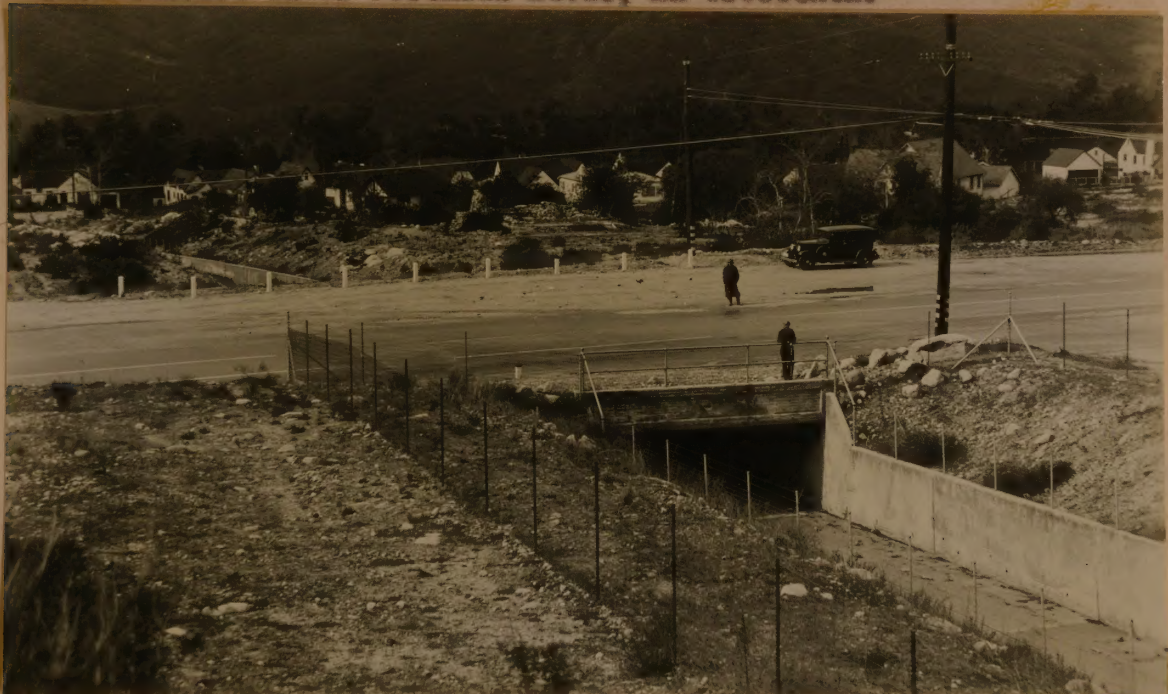
U.S.F.S. CHC-1439

2-1-58  
B. Heavily enlarged concrete storm drains, leading from canyon-mouth debris basins, protected the area in 1958. Had current storm basin of higher elevation, the filled basins were have discharged debris, with possible closing of drains and repetition of disaster.

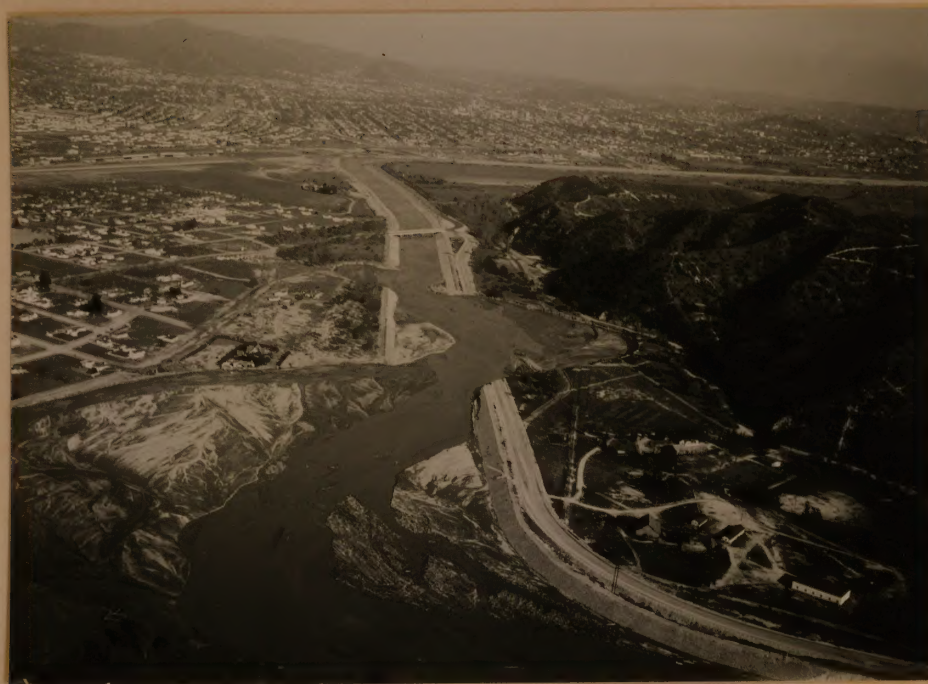
SCS (RMG-15)

- A. The torrential force of sediment-laden flood waters breached the rock-faced levees along Los Angeles River channel above Riverside Drive bridge. Mountains of Griffith Park at right.

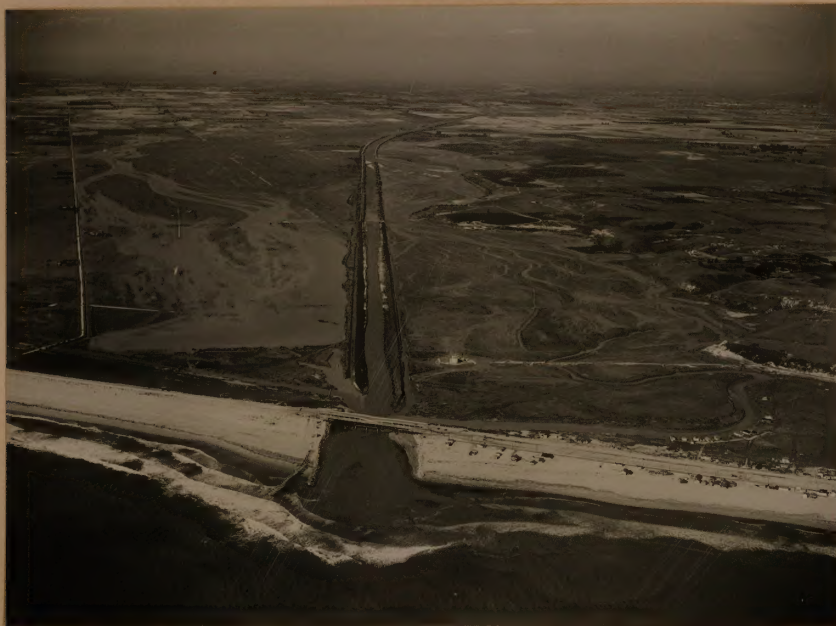
SCS (RMG-7)

- B. Extensive area of flood and deposition over agricultural lands along lower Santa Ana River. Note formation of delta at beach line.

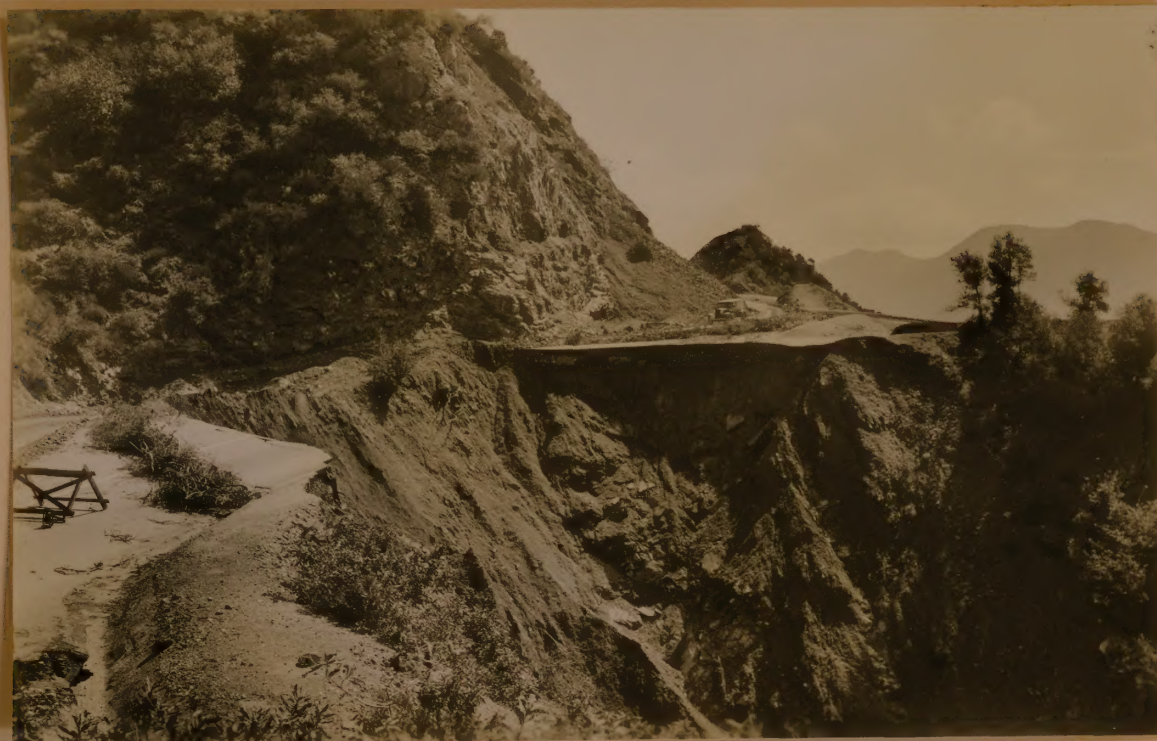
U.S.F.S. CHG-1464

A. Washout caused by side canyon drainage, Angeles Crest Highway, Los Angeles watershed. Soil loss estimated 32,000 cu. yds.

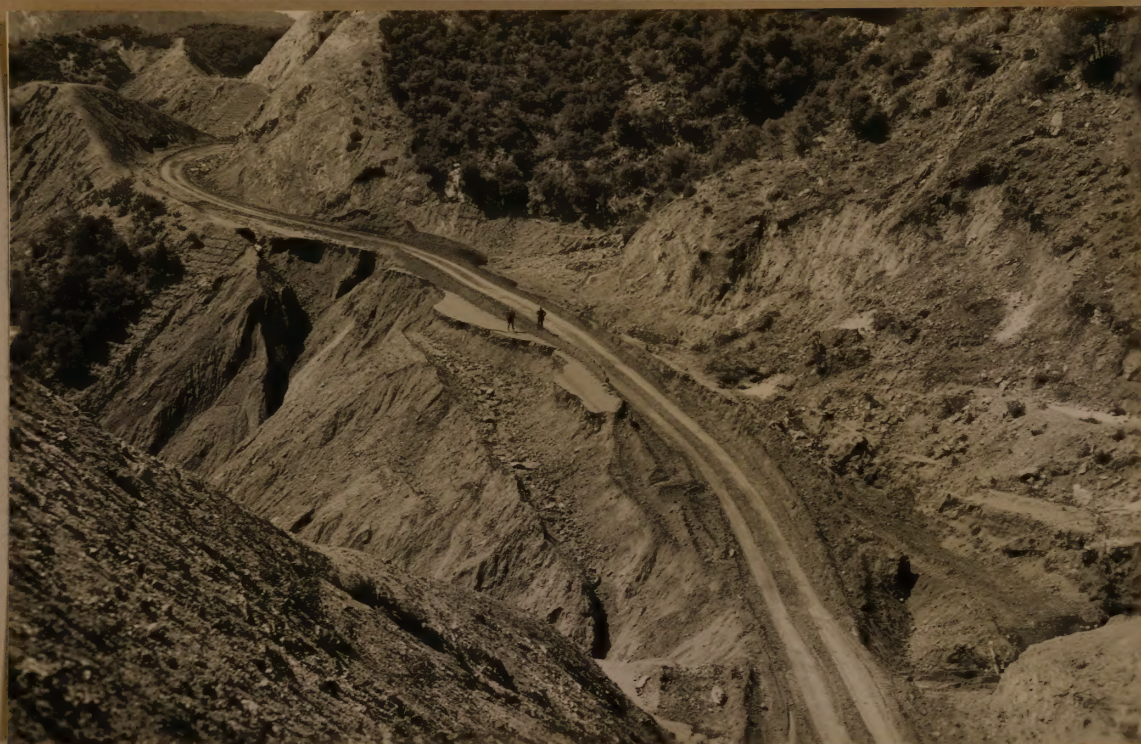
U.S.F.S. DMI-895

- A. Erosion rate for this high standard mountain highway is estimated at 150,000 cu. yds. per mile, this storm. Surface wadding and planting could not control typical destruction of fills by flows from side canyons. California State section of Angeles Crest Highway below Red Box, Los Angeles watershed. Man at left stands on remnant of original road surface.

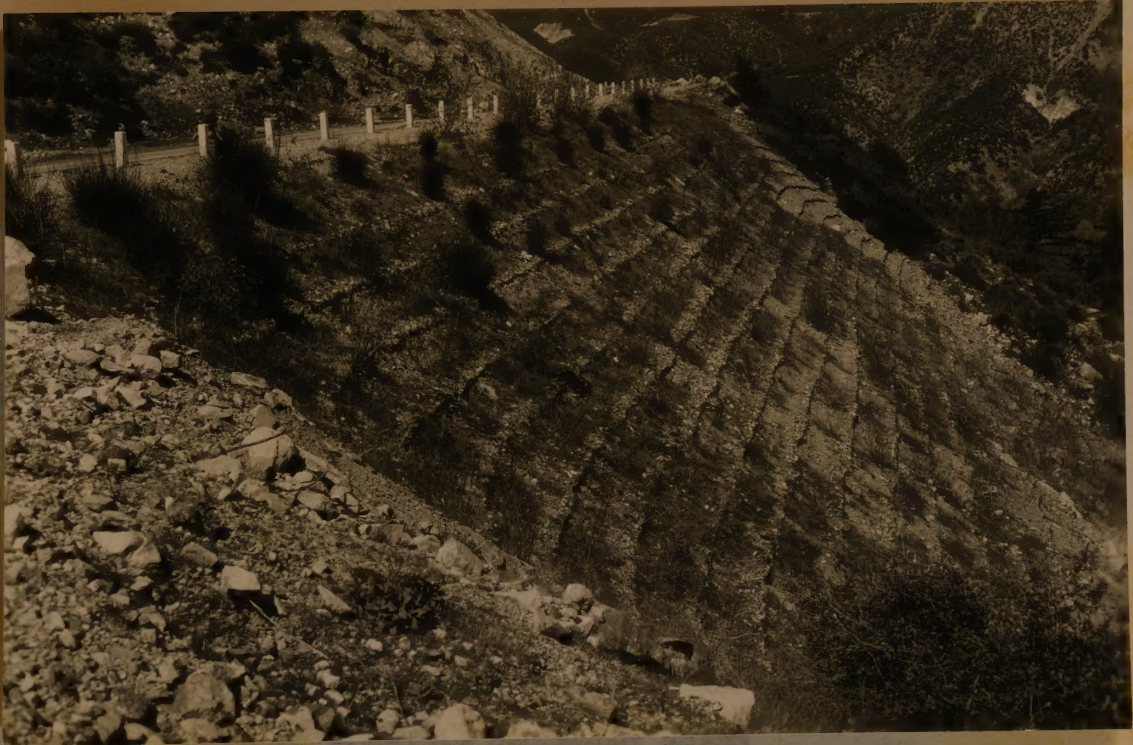
U.S.F.S. DMI-861

- A. Lack of damage to fill slope having good vegetation cover, treated by method in U.S.D.A. Circular 380. Waterman Canyon Highway, Santa Ana Watershed, San Bernardino N. F.

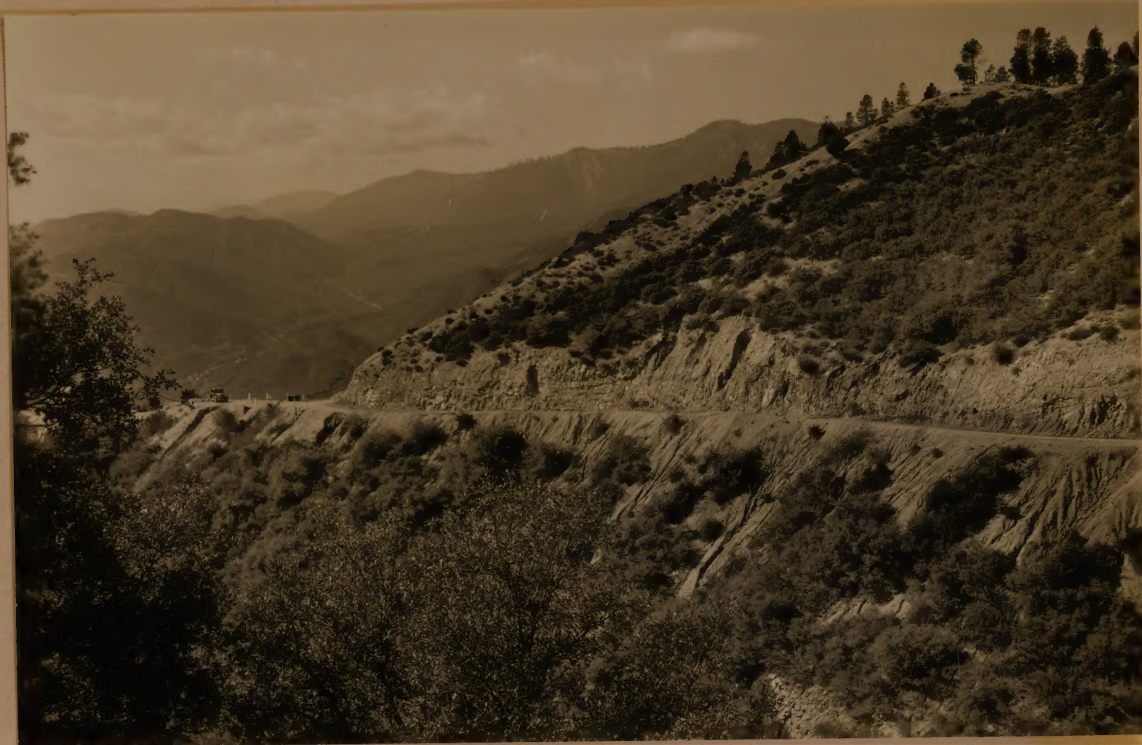
U.S.F.S. DMI-854

- A. Typically eroded overcast slopes on which no control work was attempted. Average overcast slope loss estimated 75 cu. yds. per mile. Estimated total erosion loss for road, 550 cu. yds. per mile. City Creek truck trail, Santa Ana watershed, San Bernardino N. F.

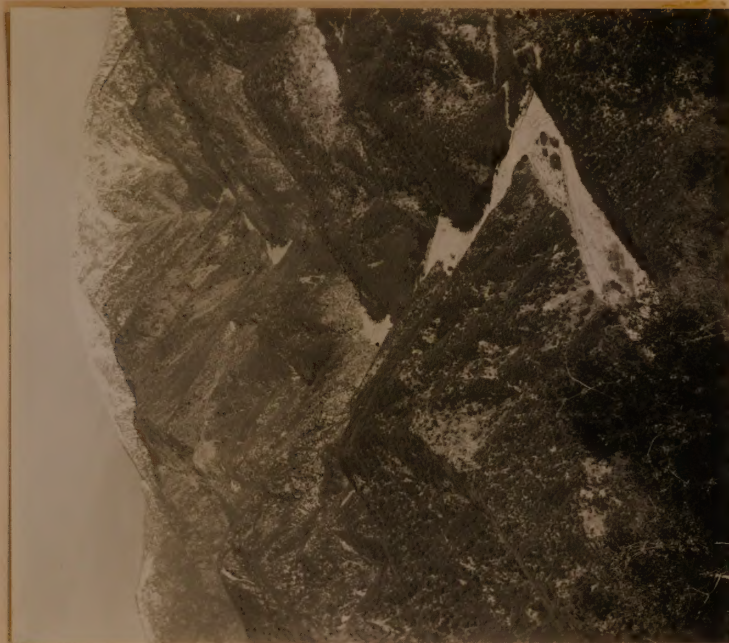
U.S.F.S. WTC-29

- A. Heavy runoff cascaded from barren granite peaks, filled canyons wall to wall, and quickly picked up a debris load of rock and boulders that effectively stripped all vegetation from the channels. East Fork San Gabriel River, springing from San Antonio Peak, elev. 10,080 ft.

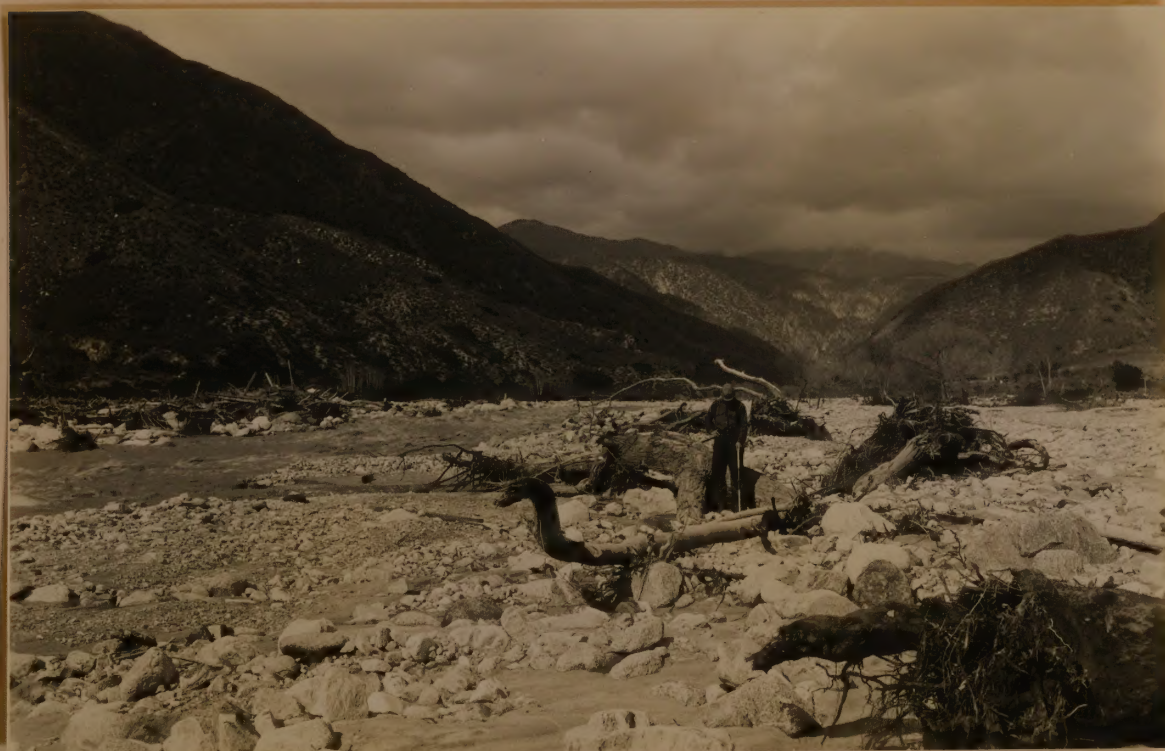
U.S.F.S. CHC-1448

B. Complete destruction of channel improvements, together with damage to and widening of wash characteristic of large stream. Thirty-six summer cabins, a CCC camp, and a Ranger Station were destroyed in this canyon alone. South of Big Tujunga Canyon, Los Angeles watershed.

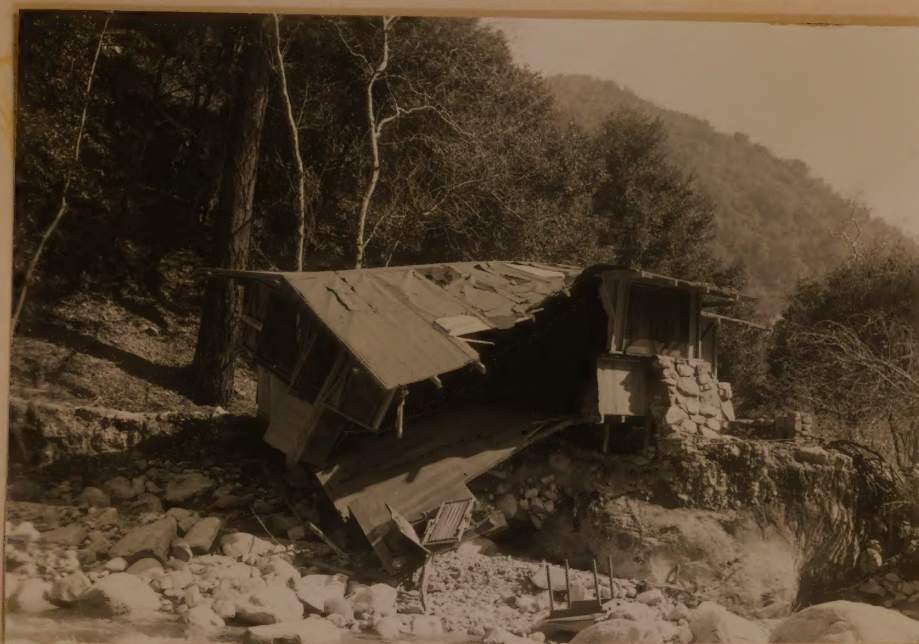
U.S.F.S. WTC-19

- A. Flood-torn remains of a summer cabin at Robert's Camp, Big Santa Anita Canyon, San Gabriel watershed. Forty-two such cabins were completely destroyed in this canyon alone.

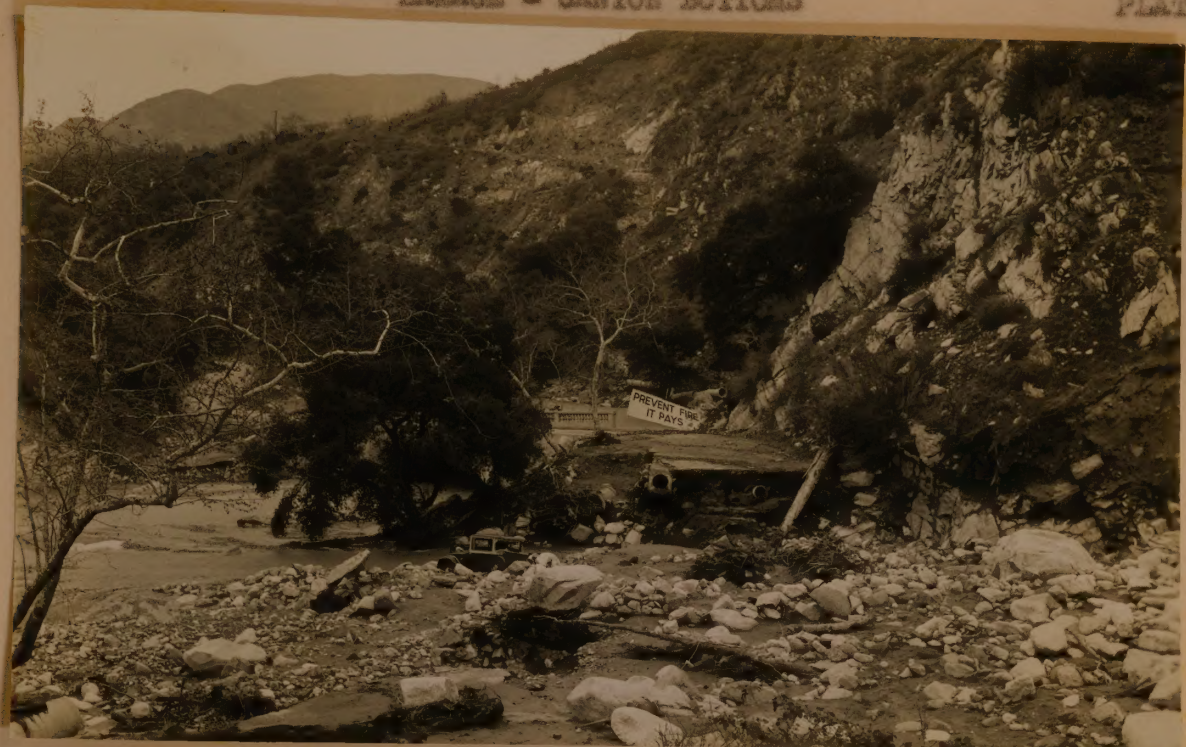
U.S.F.S. CHG-1403

- A. Typical destruction of canyon-bottom highway, requiring complete relocation of new road, with attendant loosening of soil and increase of sediments in Devils Gate Reservoir. Mouth of Arroyo Seco Canyon, Los Angeles watershed, Angeles N. F.

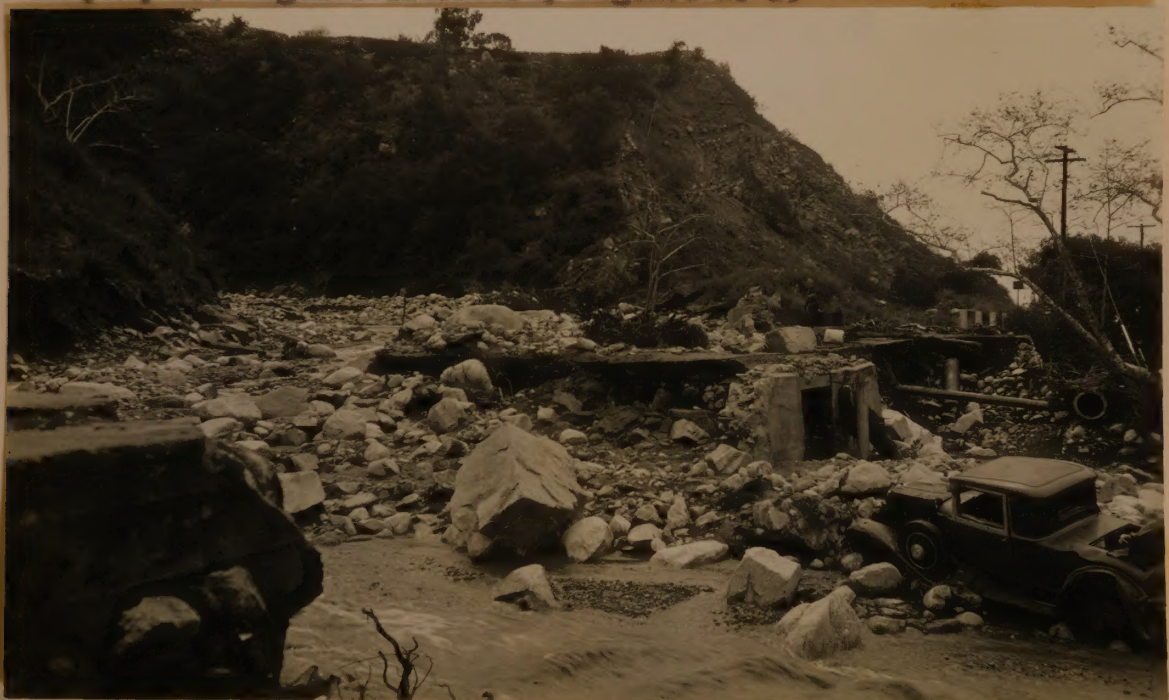
U.S.F.S. CHG-1404

- B. Site of Millard Canyon bridge, showing character of debris that destroyed it. Millard watershed was largely burned in 1934 and 1935. Arroyo Seco road, Los Angeles watershed.

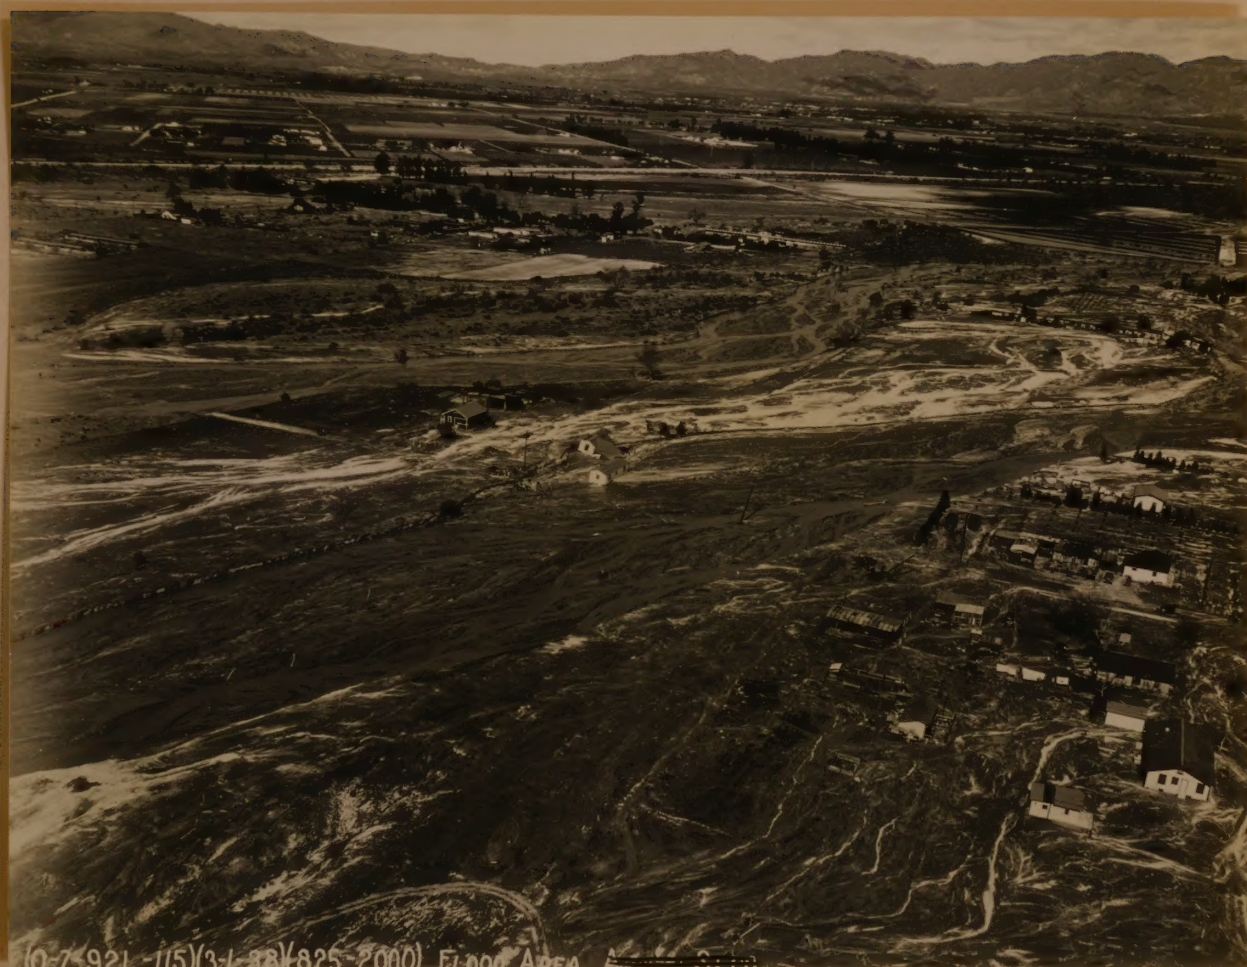
Cal. Nat. Gd. (0-7-92L-115)

Destructive spread of flood waters through suburban settlement along poorly defined, unimproved Tujunga Wash, at Van Nuys, Los Angeles watershed. The single flood control dam was inadequate.

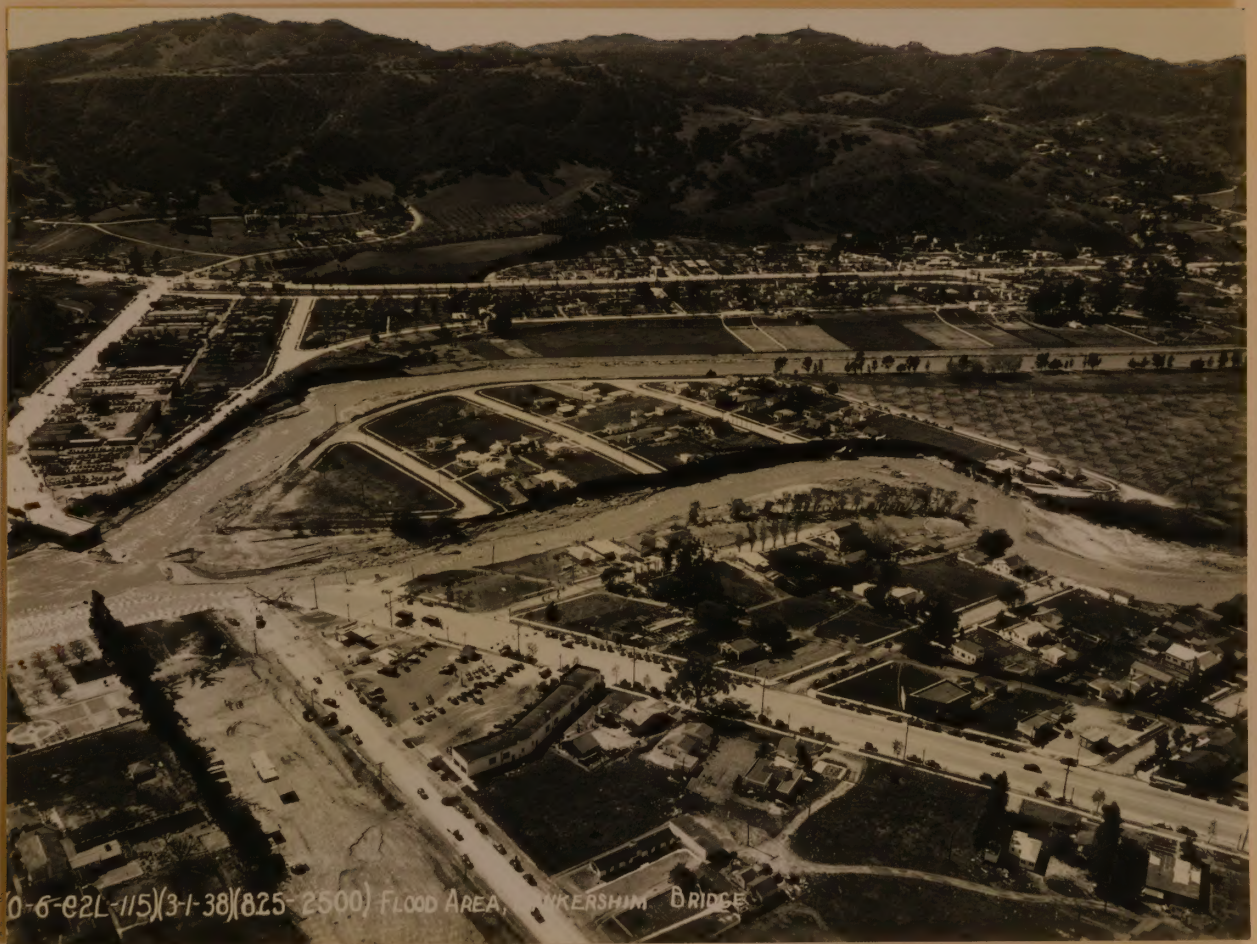
Calif. Nat. Gd. (0-6-92L-115)

3-1-53  
North Hollywood suffered severely in destruction of houses, streets  
and highways. Damages to bridge at left, at junction of  
Toluca River (near) and Los Angeles River (below).
